MERRIMACK RIVER BASIN
MERRIMACK, NEW HAMPSHIRE

MERRIMACK VILLAGE DAM

PHASE I INSPECTION REPORT
NATIONAL DAM INSPECTION PROGRAM

FEBRUARY 1979

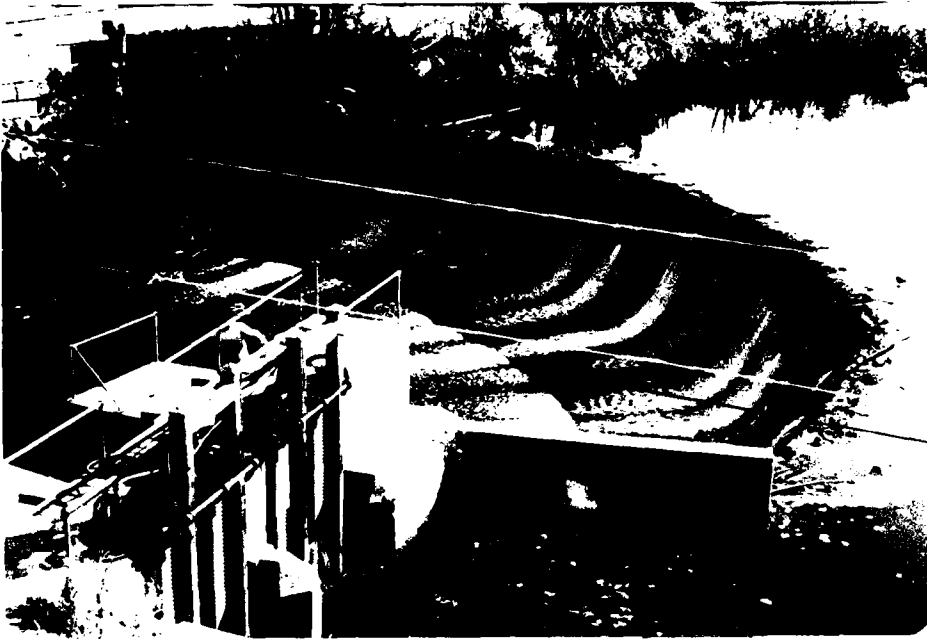
Overview of dam from fire station
on left abutment

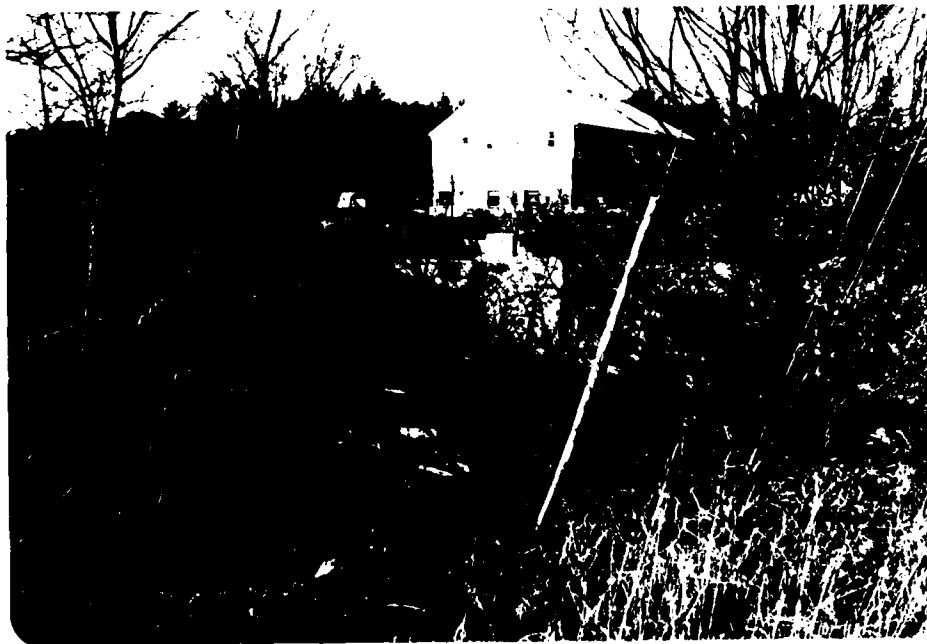
Overview of dam from right abutment

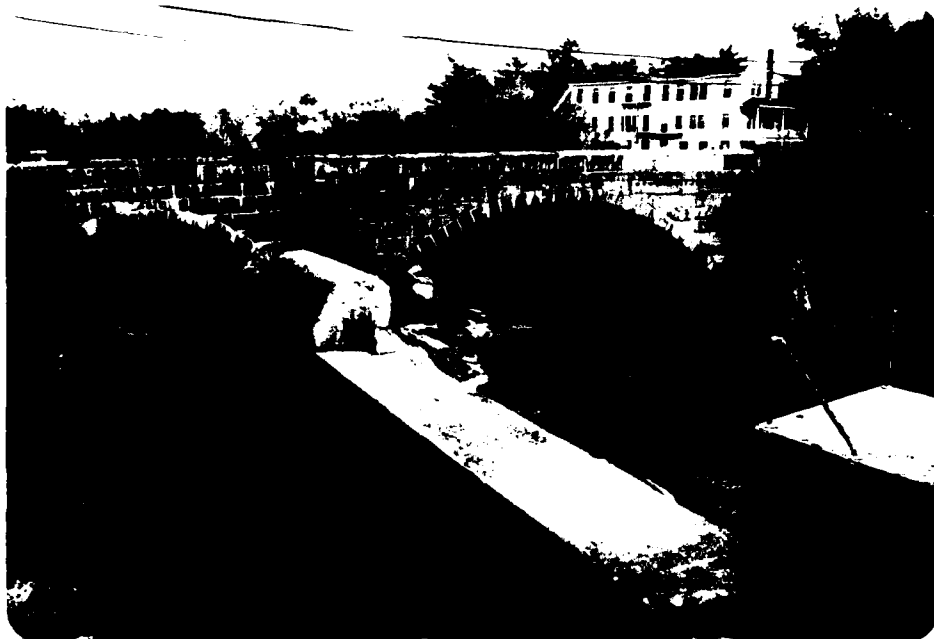
7. View of highway bridge just downstream of dam
and of the diversion channel to old mill

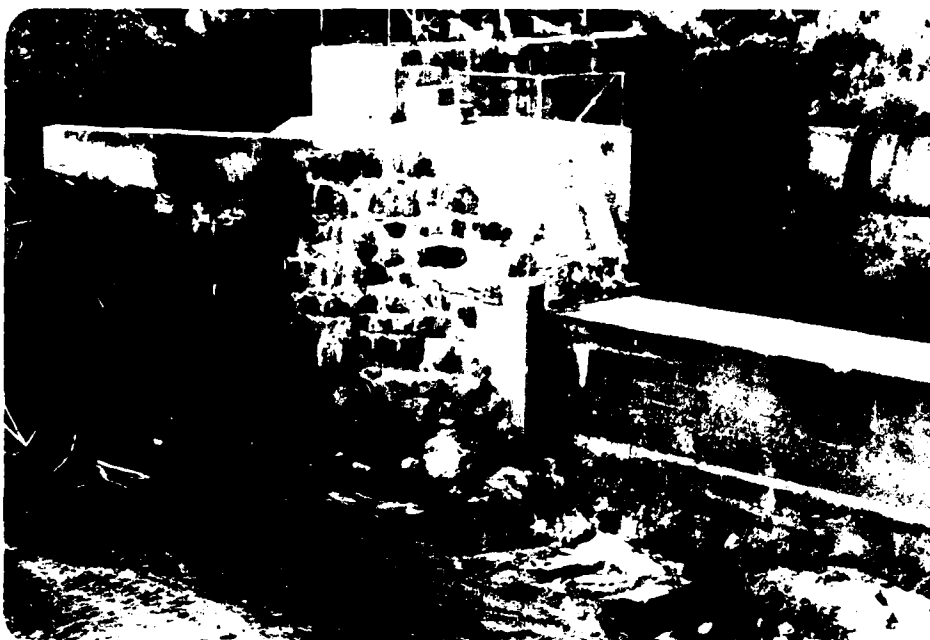
The cemented stone masonry foundation of the left abutment is in good condition, with the exception of 3 or 4 areas where seepage is flowing through the base of the masonry. The combined rate of seepage at these locations is less than 0.1 gpm. The mortared joints of this abutment are highly effloresced. The concrete capped section of this abutment over the cemented stone masonry is in good condition with the exception of a horizontal construction joint which has opened slightly with evidence of minor efflorescence at this joint. Furthermore, there is some evidence of spalling at the water line which is essentially the spillway crest elevation.

5. View from downstream channel showing voids and seepage at base of cemented rubble stone masonry and showing temporary debris

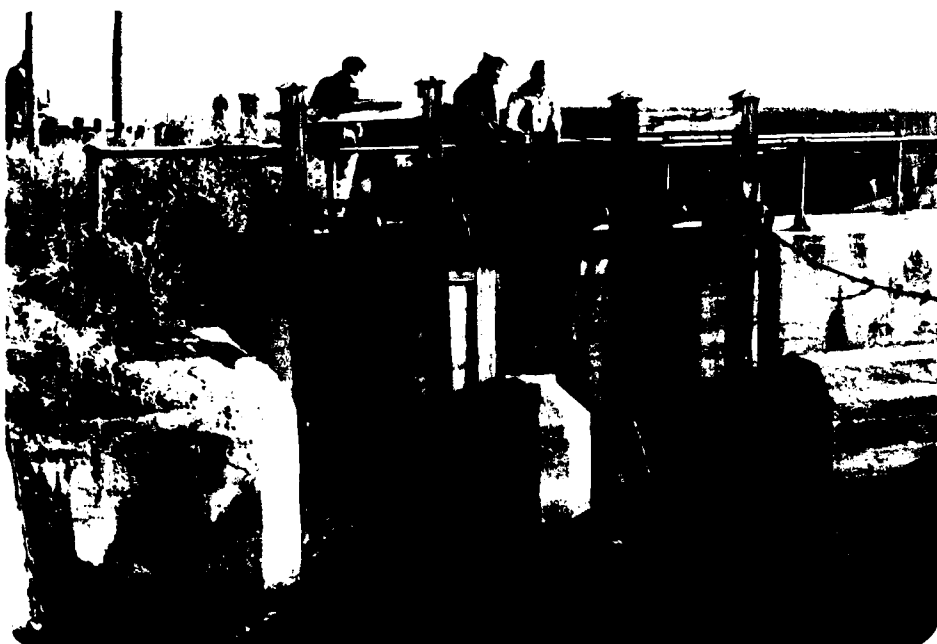
The top surface of this structure has random and web cracking over its entire surface. This is attributed to moisture intrusion. The nosing of the intermediate pier upstream of the sluice gates has been subjected to erosion at the spillway crest level which can be attributed to ice damage. The balance of the exposed upstream and downstream faces of this structure are in good condition without evidence of cracks, spalls or efflorescence. Visual observations have revealed that the sluice gates are inoperable because of the advanced stage of deterioration. A rack gear is missing from the left side of the right gate. The right yoke of the left gate is rotted at approximately crest level. Seepage is prevalent through the gates. The operating mechanisms for both gates have not been maintained. A metal plate covers the upstream face of the right gate to control seepage. Debris has accumulated in front of the gates to within one foot below the crest elevation.

3. View from upstream left side of gate structure
